GEORGIA INSTITUTE OF TECHNOLOGY
OFFICE OF CONTRACT ADMINISTRATION
SPONSORED PROJECT INITIATION

Project Title: Utilization/Evaluation of AID Hand Pump

Project No: A-1894

Sponsor: Agency for International Development

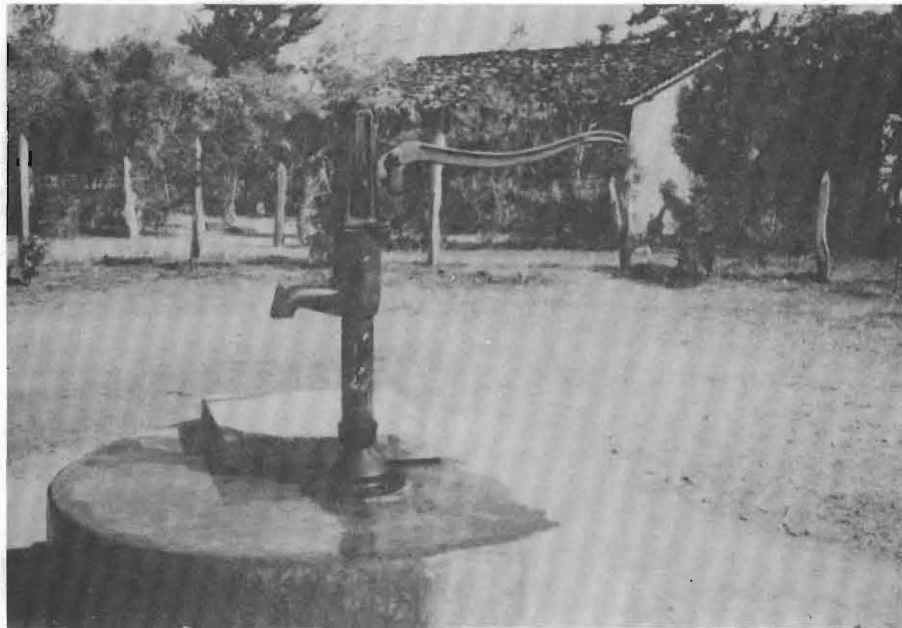
FIGURE 3. AID DEEP-WELL MODEL HAND PUMP
(NICARAGUA)

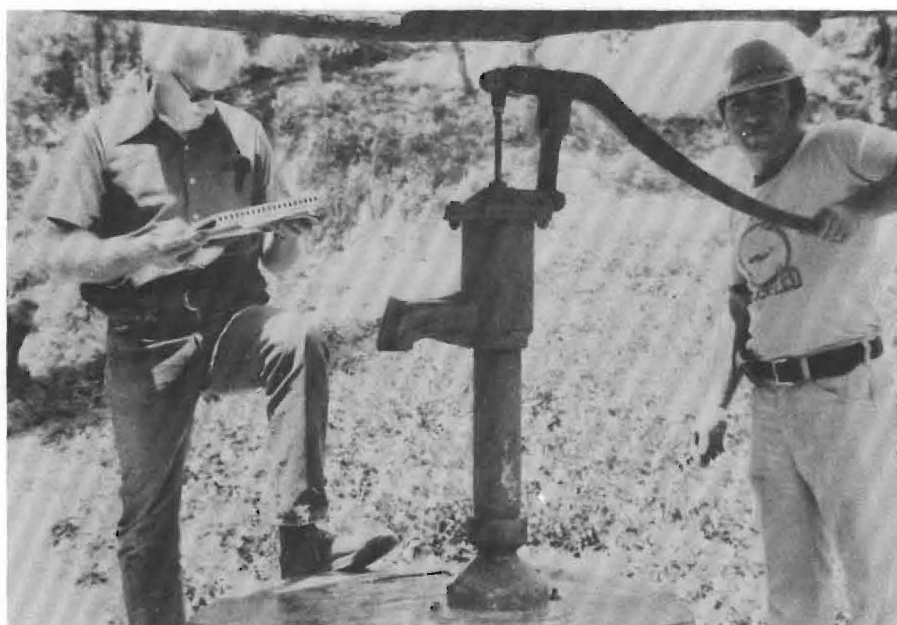
FIGURE 8. AID DEEP-WELL MODEL HAND PUMP WITH CAP
DESIGNED BY COSTA RICAN FOUNDRY

Even though Costa Rican Ministry of Health officials decided not to adopt the AID hand pump for future installations, they later made the decision to locally manufacture a hand pump that contained many of the features of the AID pump. For Georgia Tech and AID, field test results clearly highlighted the modifications necessary to make the AID pump acceptable in a developing country environment. These modifications were essentially to use the cap design modifications developed for Nicaragua on both deep-well and shallow-well models and to use a double-cup arrangement with the piston assembly for longer life of the cups and for a better seal.

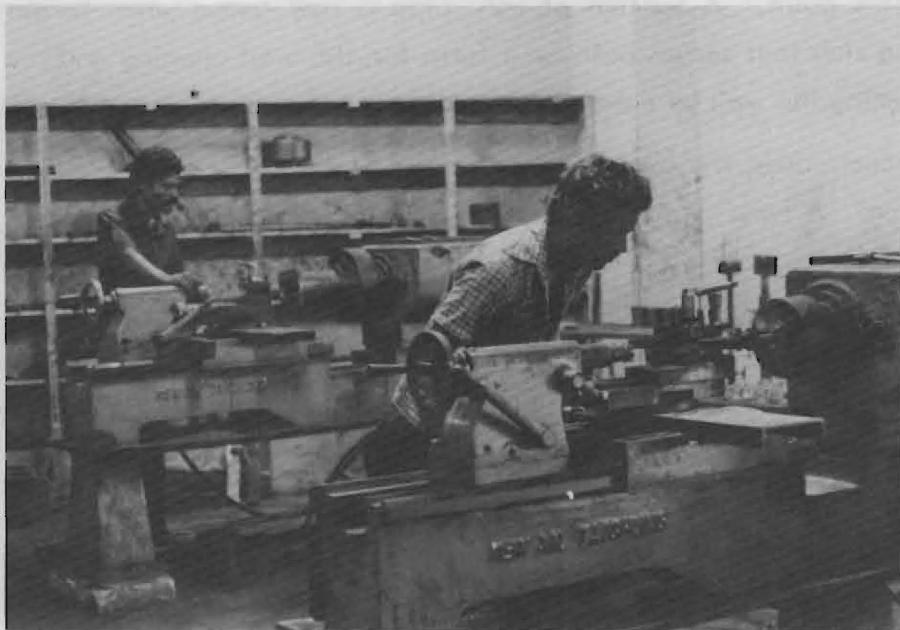
FIGURE 10. PRODUCTION OF THE AID HAND PUMP IN THE
FOUNDRY/MACHINE SHOP, EQUIPO TECNICO INDUSTRIAL
(DOMINICAN REPUBLIC)

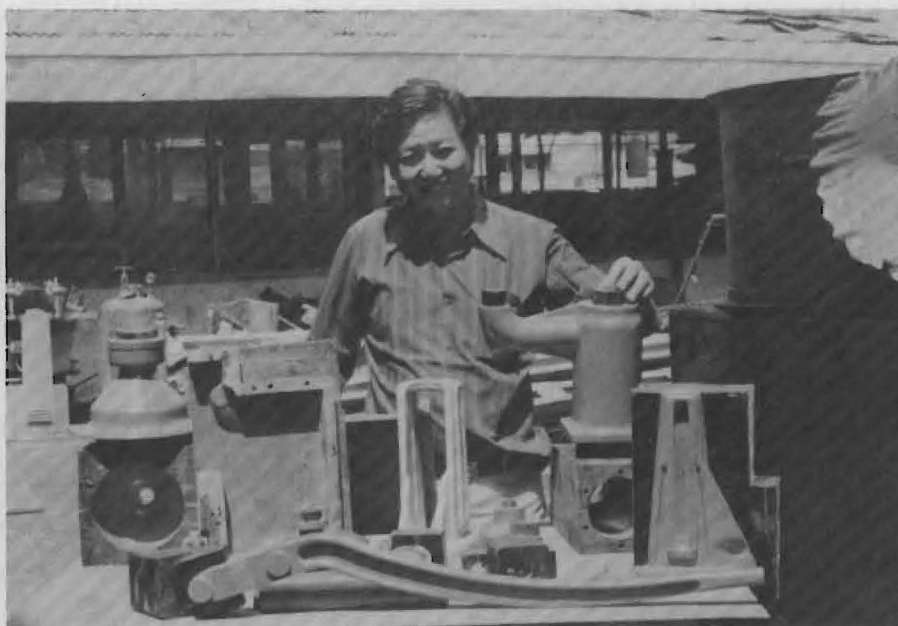
FIGURE 13. MR. TANO T. JAKRASASMITA, THE OWNER/MANAGER OF CELCO TECHNICAL INDUSTRY, DISPLAYS HIS WOODEN PATTERNS OF THE AID HAND PUMP (INDONESIA)

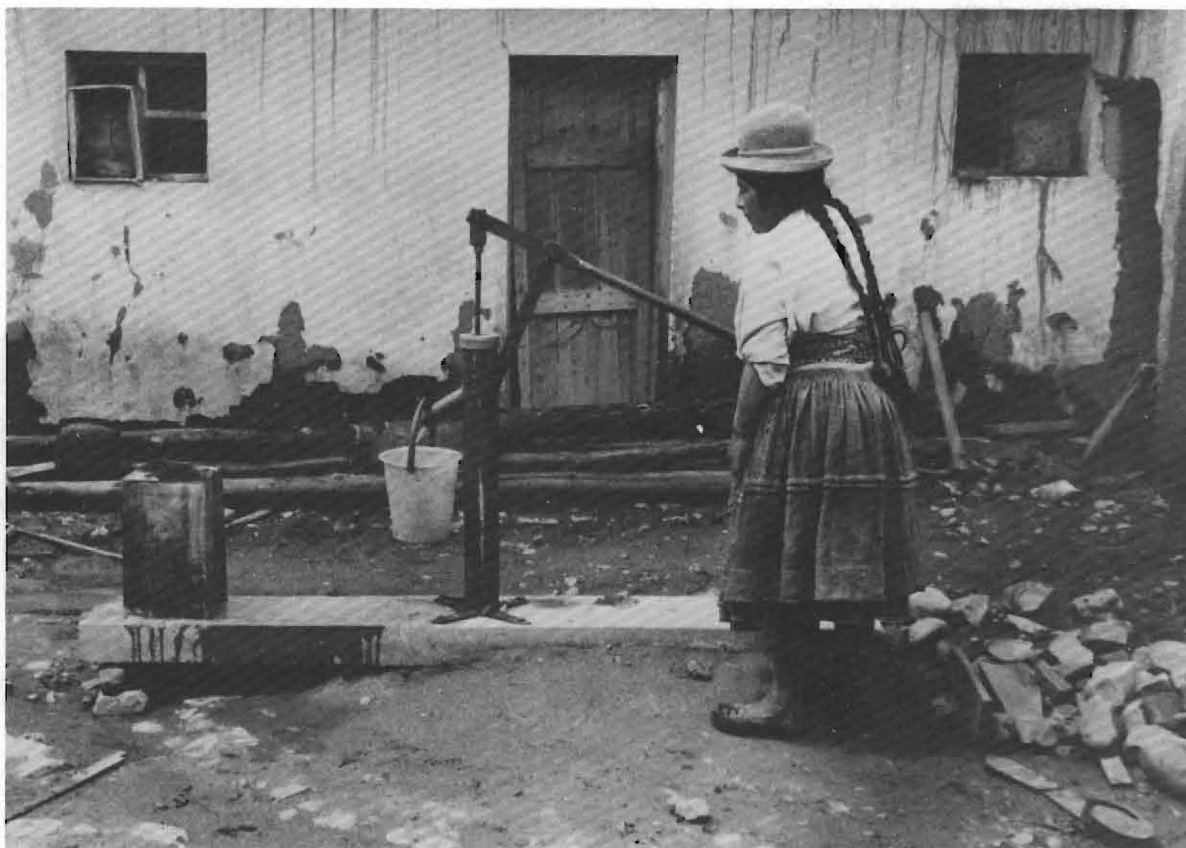
FIGURE 23. AN INGAVI HAND PUMP INSTALLED IN THE COMMUNITY OF ACHICA ARIBA IN THE PROVINCE OF INGAVI, BOLIVIA

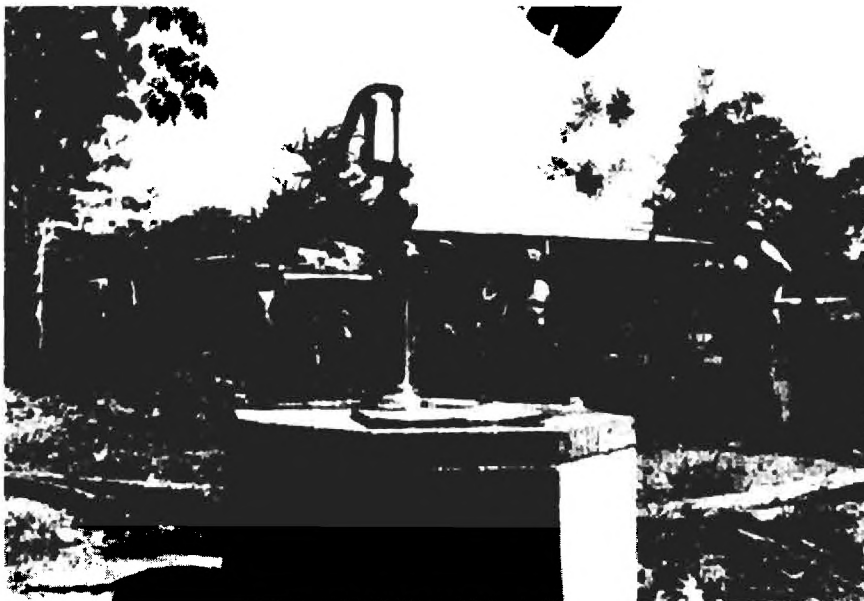
Costa Rica Site No. 15, located at San Buena Ventura de Colorado, prior to installation of field test pump. Photo taken January, 1977.

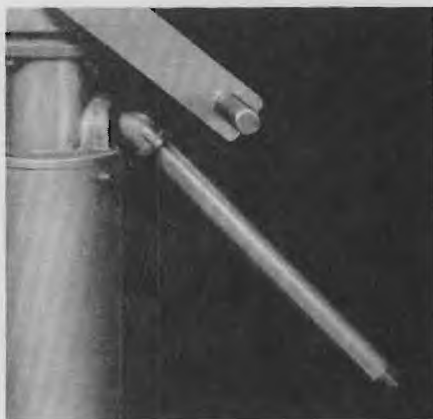
Long, angled discharge spout prevents possibility of sticks and stones being dropped or forced into the well by mischievous children.
